SOMERVILLE CITY HALL

CPA FUNDING APPLICATION PACKET

EXISTING CONDITIONS REPORT SOMERVILLE CITY HALL

The City of Somerville has commissioned CDR Maguire Inc. to perform a comprehensive building assessment of the Somerville City Hall to identify existing building deficiencies, prioritize their repairs and provide an associated construction costs to perform the identified issues.

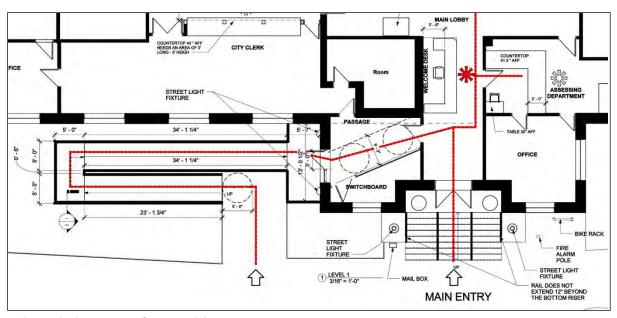
Enlarged plan view of accessible ramp

The one issue with the ramp is the length of the first run. According to the accessibility the maximum length of a ramp run between landings shall not exceed 30' (521 CMR – 24.4)

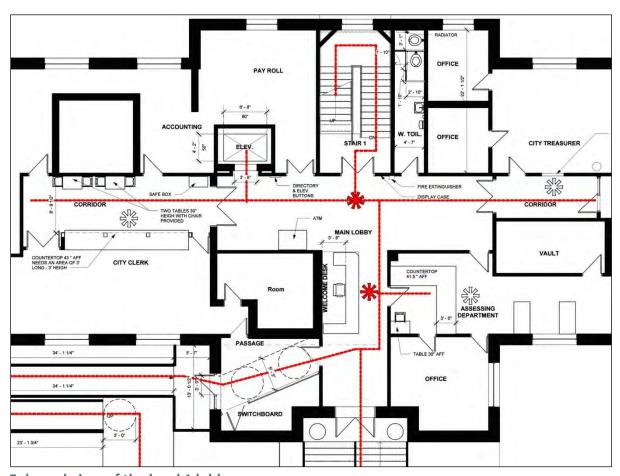
Enlarged view of the level 1 lobby

The Reception/Welcome desk is 44" high and The City treasurer counter height is 43", both do not provide a 36" high auxiliary table because of lack of space. Assessing Department Desk is 42" high and provides a small table 30" counter height. The City Clerk Counter height is 43" there are two small 30" counter height tables provided in the opposite side of the corridor.

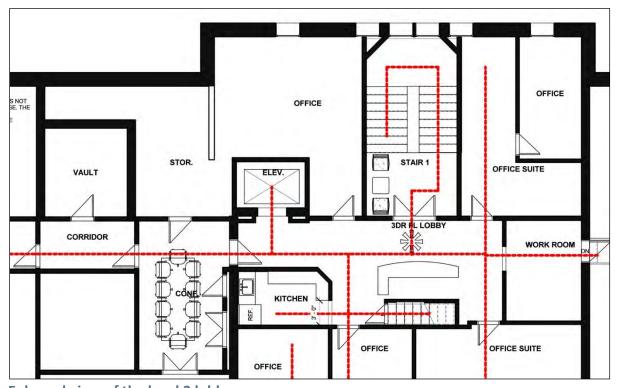
Enlarged view of the level 3 lobby

There is no portion of the counter of the third floor reception desk that is 36" above the floor and 36" long. The waiting area located at Stair 1 landing does not provide a space for a wheel chair.

Kitchenette is not accessible, and numerous doors do not have the proper clearances on the pull and push side of the door.

Recommendation: Renovate kitchenette and reception desk to be accessible. Utilize

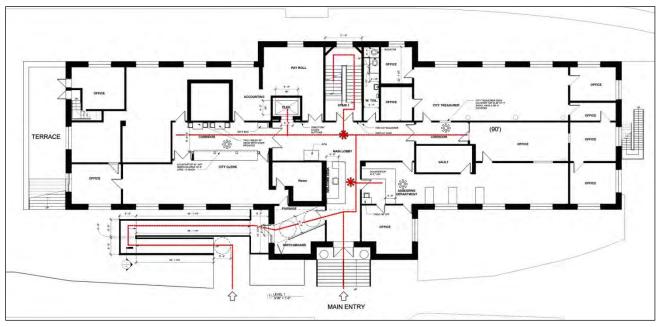
First Floor Plan

There is not a second means of egress from the north or the south wings on the first floor. In order to exit from any of the departments is necessary to return to the Main lobby to find your way out through the main door. The passage in front of the switchboard coming from the accessible ramp has furniture obstructing the mandatory 32" clear width of the door.

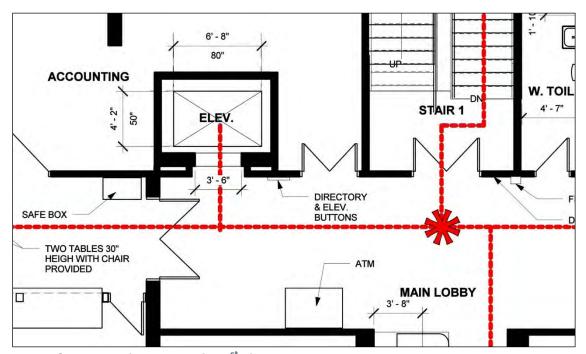
View of existing elevator at the 1st Floor

Existing elevator cab is 50" x 80" and does not meet the size requirements for an accessible cab. However, in existing buildings, where existing shaft configuration prohibits strict compliance with the building code, the code allows for a cab to be the maximum size allowable to fit within the existing shaft. As long as the inside car area is no smaller than 48 inches by 48 inches, wall-to-wall and wall-to-door.

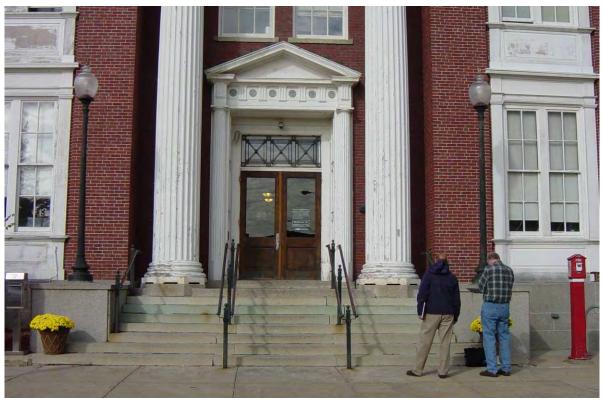
1. The sealant at the Main Entry steps is missing in many places, some stone is damaged and railings need to be scraped, primed and painted. See photo 1.

Photo 1 - Sealant is badly deteriorated at granite steps of Main Entry. Handrails are scratched and rusting. Painted columns, window and door surrounds are in poor condition.

Recommendation: Replace sealant, repair steps, paint railings.

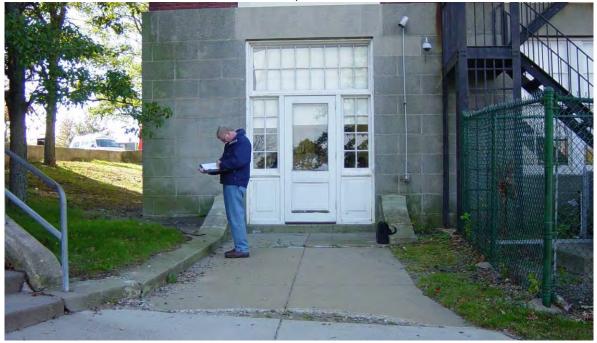
2. Other miscellaneous areas of deteriorated concrete walks, steps and curbs were noted. See photo 2.

3. The Fire Escape is rusting, and one steel post has separated from its base. See photo 2.

Photo 2 - Run-off flows around northeast corner of building. Sidewalk and curbs are badly cracked. Fire escape is rusty and needs painting and repairs.

Recommendation: Remove and replace areas of damaged concrete.

Recommendation: Repair damaged metal. Strip and repaint fire escape.

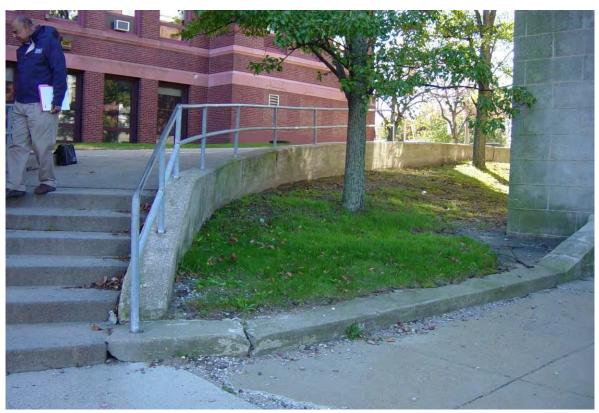
4. The retaining wall near the Northeast corner of the building is beginning to lean. It will likely last several years before completely failing. See photo 3.

Photo 3 - Concrete retaining wall is beginning to lean, but not showing signs of imminent failure.

Recommendation: At its current condition the retaining wall should be monitored to

make sure that its condition does not worsen. At the same time plans

should be implemented to either repair or replace the wall.

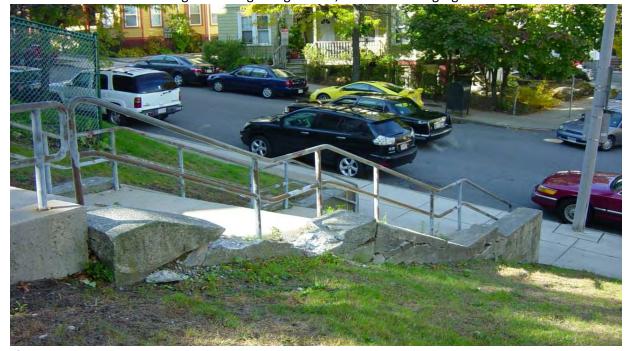
5. The concrete steps to School Street at the North side of the building are badly deteriorated, and the treads slope downward, creating a dangerous slip hazard in icy conditions. See photos 4-5.

Photo 4 - Concrete walls are badly cracked at staircase. Railings are rusting.

Recommendation: Complete replacement of steps, sidewalls and railings. This is a safety

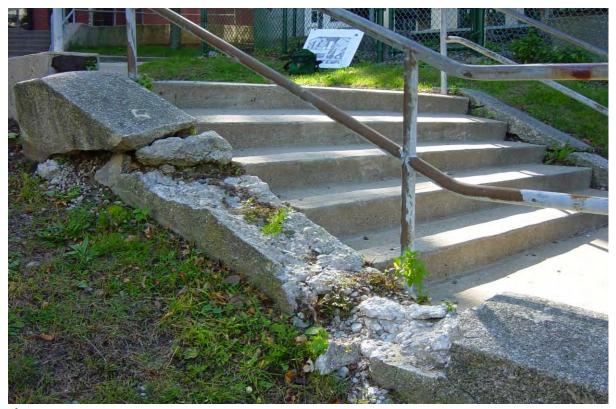
Photo 5 - Treads slope downhill, creating a serious slip hazard when ice is present.

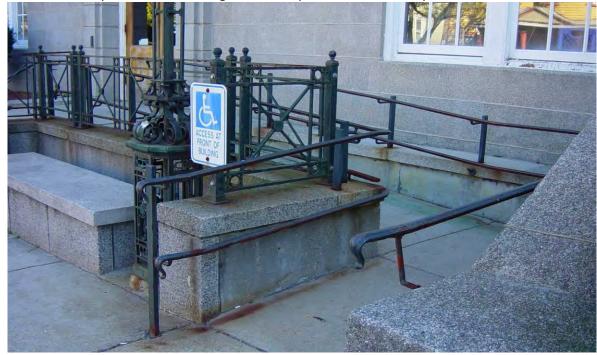
6. The Basement level entrance stairs and ramp have rusted and loose railings, loose lamp posts, and cracked granite steps. See photos 6-7.

Photo 6 - Ramp to basement does not meet Accessibility Code (MAAB). Ramp is too narrow and railing profiles do not conform. Lamp posts are loose.

Recommendation: Provide new railings, repair step and re-anchor lamp posts.

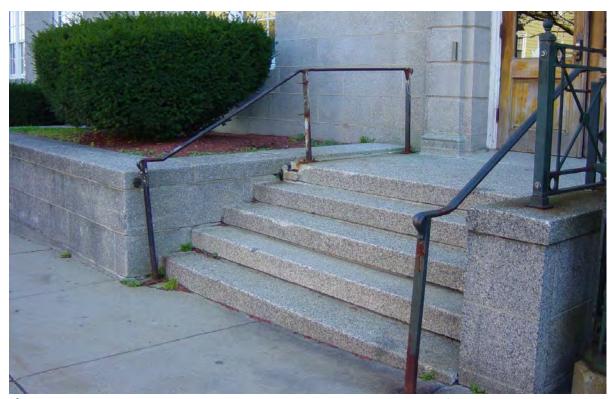
Photo 7 - Steps and railings are damaged. Exterior doorways have worn finishes and hardware, typical.

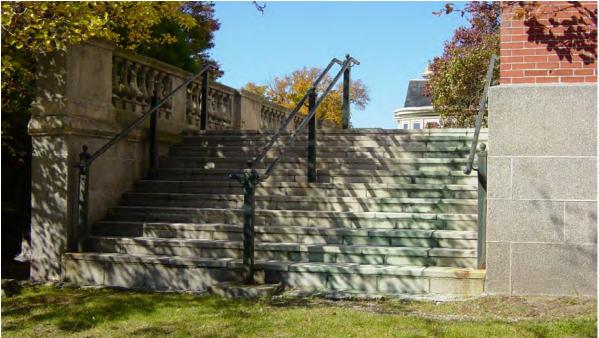
7. The Terrace on the South side of the building is leaking water and tar into the office below. Moss, plant growth and organic debris is seen on the terrace and below the pavers, and must be removed for proper function of drains. Some deterioration of the cast stone guardrail was seen. The first riser of the steps leading to the Terrace on the South side of the building is higher than the rest. See photos 8-10.

Photo 8 - Riser at bottom step is too high. Build up grade below steps to make bottom riser equal to others.

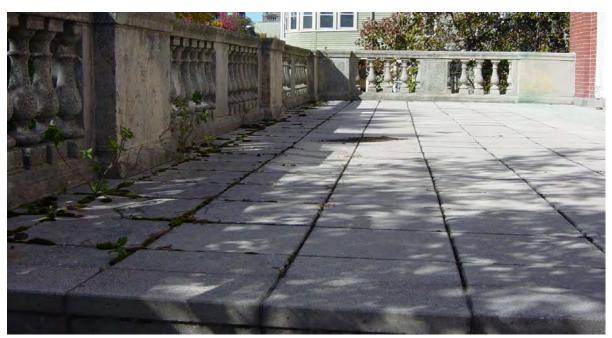
Photo 9 - Terrace waterproofing is failing, causing water and tar leakage at offices below. Moss and plant growth is seen and should be removed for proper function of terrace drains. Some deterioration of the cast stone guardrail was seen.

Recommendation: Remove pavers and clean out debris. Inspect and clean drains.

Remove and replace waterproofing membrane. Reinstall pavers, replacing broken ones. Insulate exposed drain pipes at Basement office to prevent condensation. At guardrail, clean all cast stone, patch all damaged cast stone with concrete repair mortar to match existing, and apply a penetrating water repellent and consolidation treatment to all surfaces. Prune trees and bushes away from terrace. Build up the grade below the steps to make bottom riser equal to the

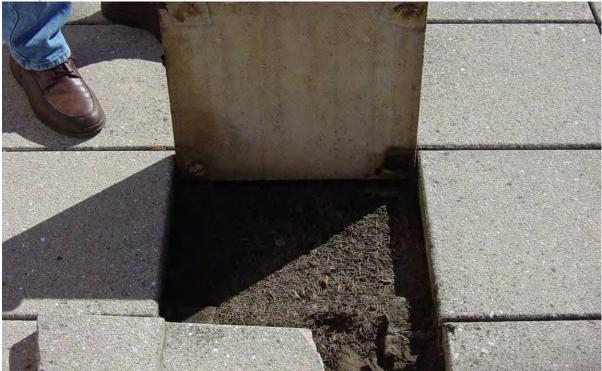
Photo 10 - Terrace pavers need to be removed to clean out organic debris, which is clogging the drains. Some pavers are cracked and need to be replaced. Drain pipes need to be insulated to prevent sweating.

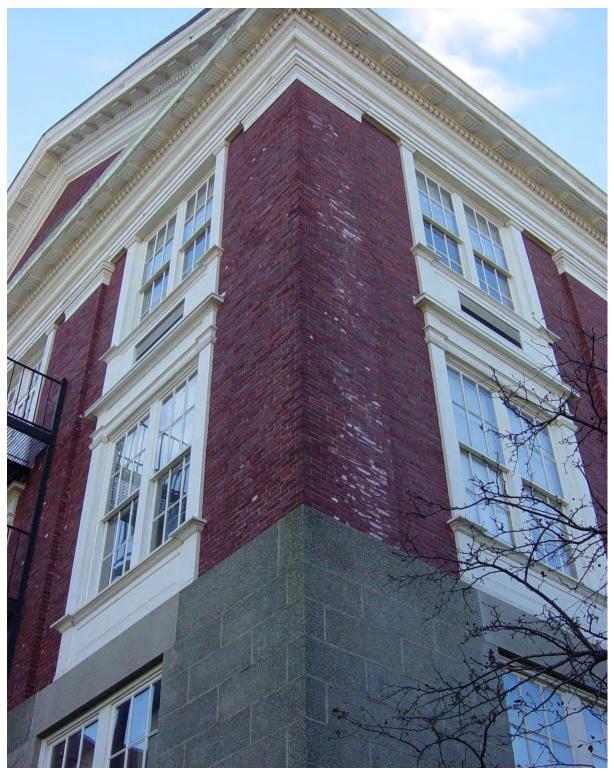
Photo 11 - Brick walls, granite base and building mortar are in good condition. No settling or cracking of masonry was seen. Due to weather, the northwest corner of building showed the most deterioration to the

mortar. The grilles, seen below the Second Floor windows in the Alderman's Chamber, let in wind-driven rain, causing water to drip in the offices below.

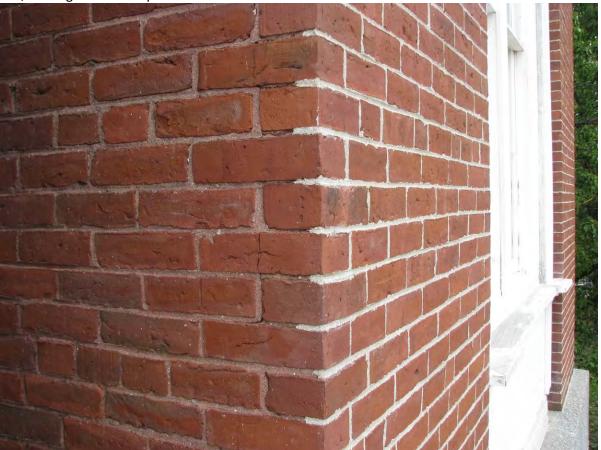
In general, the masonry exterior components are in good condition. Approximately 2/3 of the brick was re-pointed in 1995, including the South side of the building and the two main entrances. However, at that time the entire North wing of the building and the third floor were not re-pointed, and the mortar in these areas is severely deteriorated. See photo 12. Not surprisingly, the interior finishes in these areas are also more deteriorated than on the South side; most likely attributed to the poor condition of the mortar, and more severe weather exposure. We strongly recommend repointing all areas of brick that were not performed in 1995.

Photo 12 - This photo contrasts brick that has been re-pointed, on the right, with brick that has not been re-pointed, on the left. The grout on the left is very porous and deteriorated, letting in water which in turn leads to cracking of the brick and deterioration of paint and plaster on the inside surface.

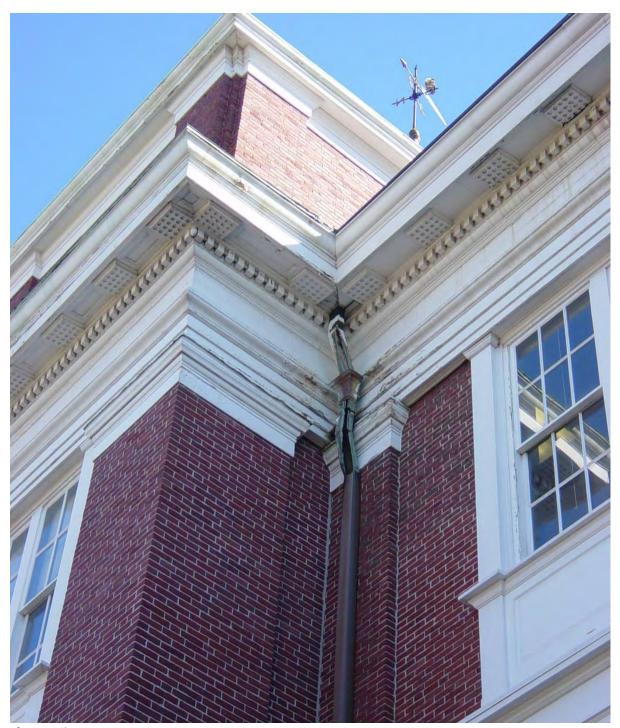
Photo 13 - Paint at wood cornices and other wood trim is peeling, in some cases badly. Some copper downspouts have split, causing large amounts of water to spill down the face of the building. Below this downspout, which is adjacent to the Accounting Office, water has damaged the interior wall surface.

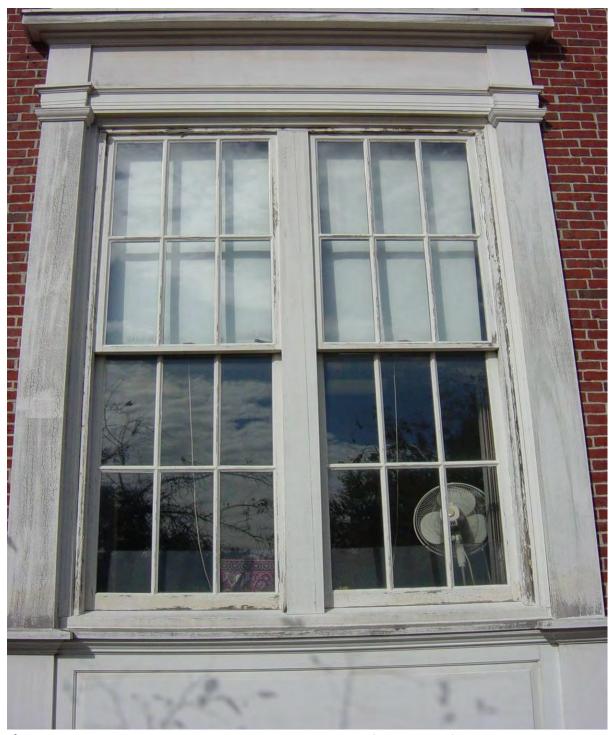
Photo 14 - Windows are single hung, wood sashes and frames retrofitted with insulated glazing and weather stripping. The condition of the windows is good, but the sashes have excessive play, some weather stripping is missing, the glazing compound is cracking, and painting is needed.

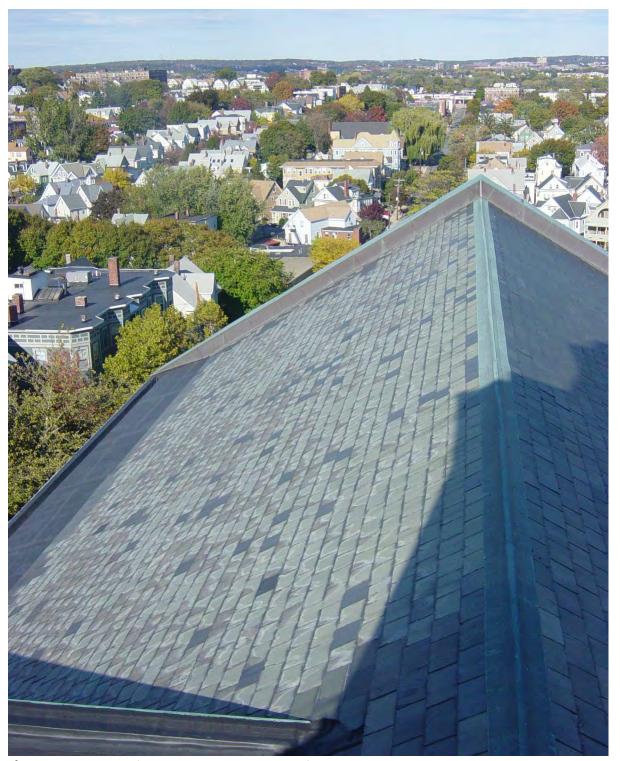
Photo 15 - Slate roofs are in good condition. A few cracked and missing slates were seen. Built-in EPDM lined gutters appear in good condition. The copper ridge appears to be in good condition.

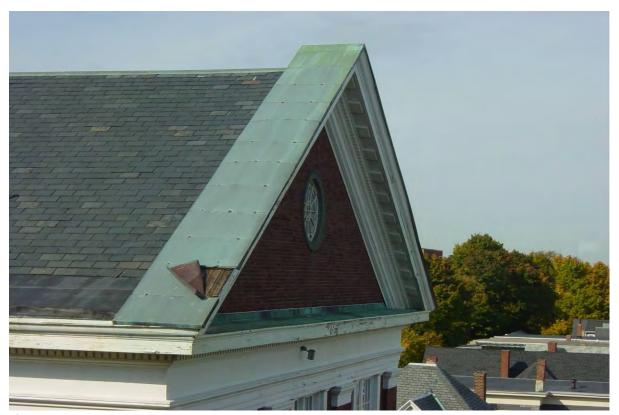
Photo 16 - Several areas of the copper coping are damaged and in need of repair.

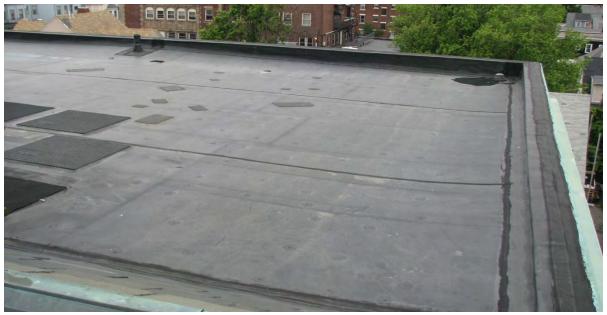
Photo 17 - The flat EPDM roofs are approximately 19 years old and in fair to good condition. Some roof drains are damaged and in need of repair.

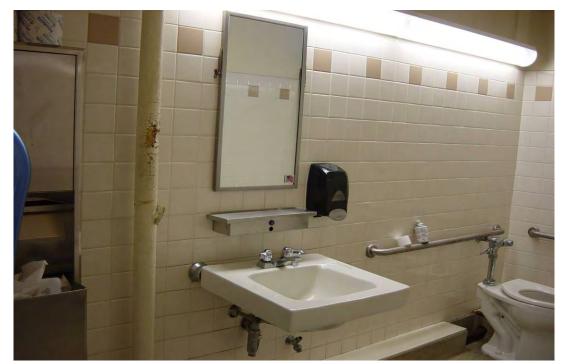
1. Basement Bathrooms: Pipes and radiators are badly rusted and unsightly. See photo 18. Mechanical ventilation, a Code requirement, is absent. Slide bolt locks at bathroom doors interfere with power door operators and are not handicap compliant. Inadequate stalls cause inconvenience.

Photo 18 - Basement bathrooms are single-user, causing inconvenience. Rusty pipes and radiators, mismatched accessories, unpleasant lighting and deteriorated floors give unattractive appearance.

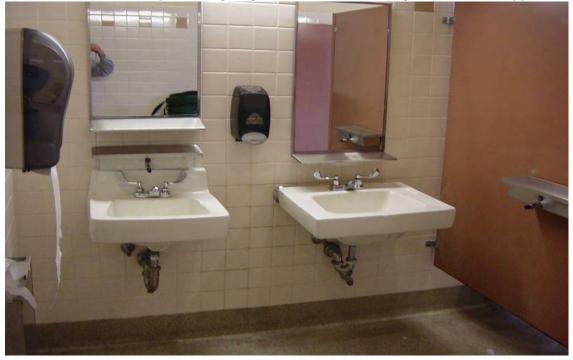
Photo 19 - Second floor bathrooms are well maintained. Appearance is somewhat worn and mismatched.

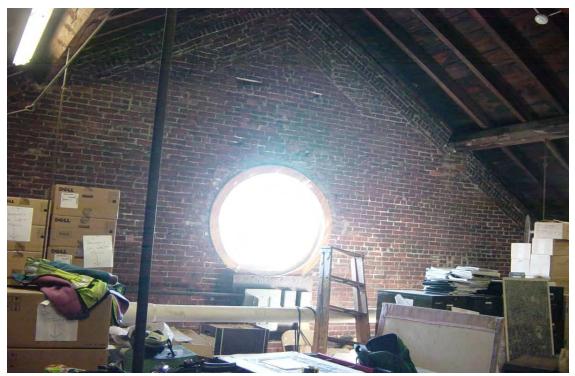
Photo 20 - Existing south attic has exposed brick wall, window and roof timbers. Steam pipes obstruct space.

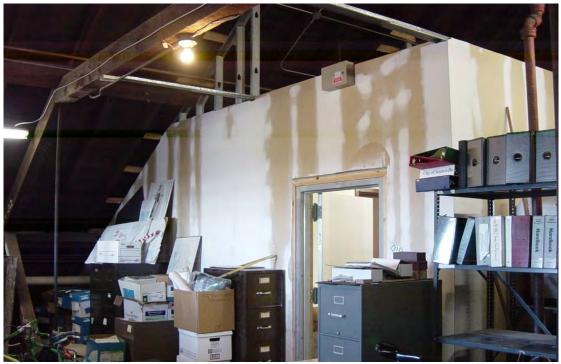
Photo 21 - Attic is currently crammed with old files and drawings. Tension rods and braces obstruct space.

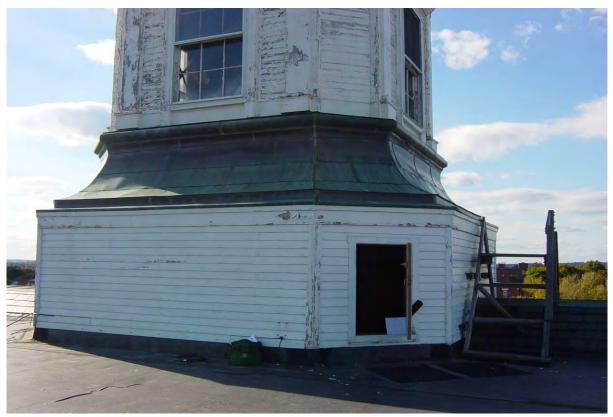
Photo 22 - The clock tower is clad in painted clapboard, wood trim and copper roofing. It has three floor levels, the lowest of which exits onto the flat roof. The crossover stairs on the right are used for accessing the west roof and mechanical equipment. It is missing treads, poorly built and hazardous. Replacement is recommended.

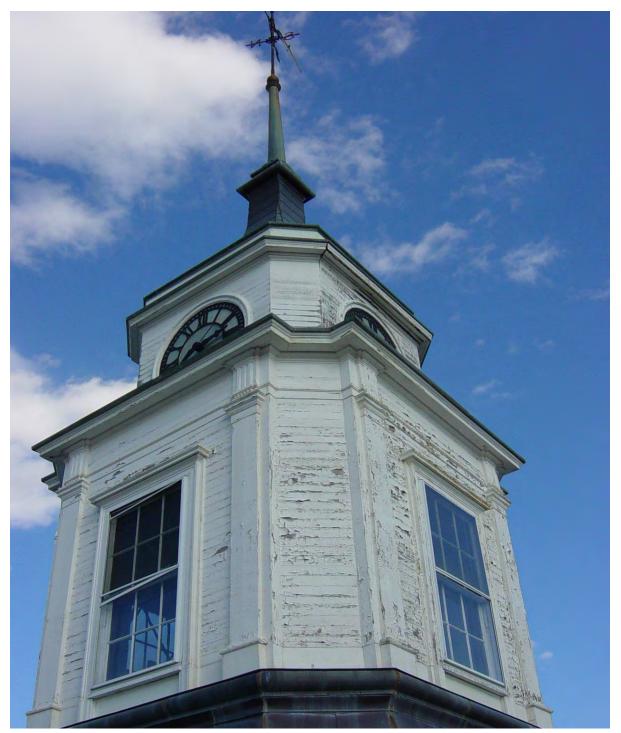
Photo 23 - The clock tower paint is peeling badly. Some wood trim is loose and in need of repair. Windows are in very poor condition. They have not been fitted with insulated glazing as was done elsewhere. Non-historic storm windows have been shattered due to high winds. The copper roofs appear to be in good condition, and no water was seen leaking from the steeple in moderate to heavy rains.

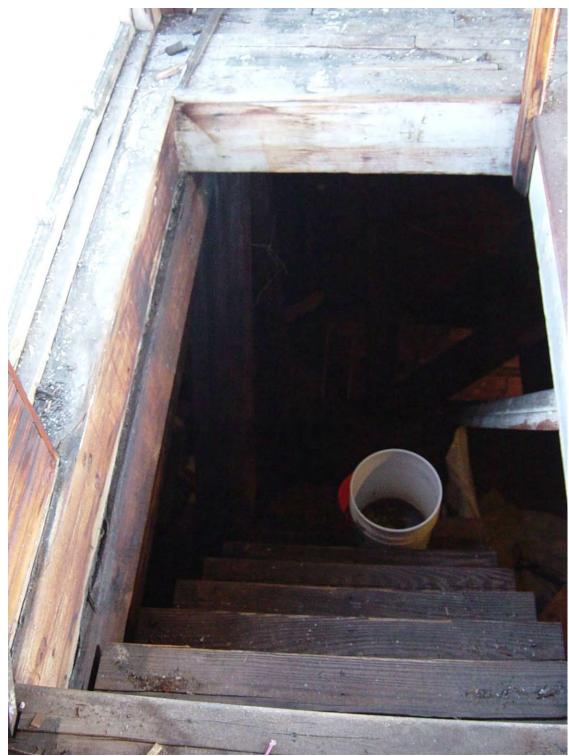
Photo 24- The stairs ascending the clock tower are very steep, with loose, cracked treads and inadequate railings. Buckets are propped to catch leaks.

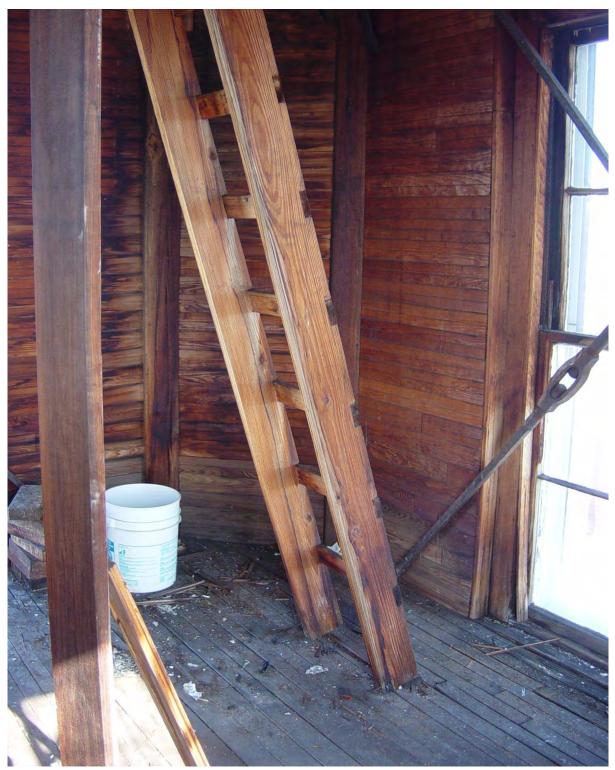
Photo 25 - Ladder to clock room is unsafe, some rungs are loose and it does not meet OSHA standards. Walls and floors are water damaged. Windows are rotted and leak. Floors are littered with debris.

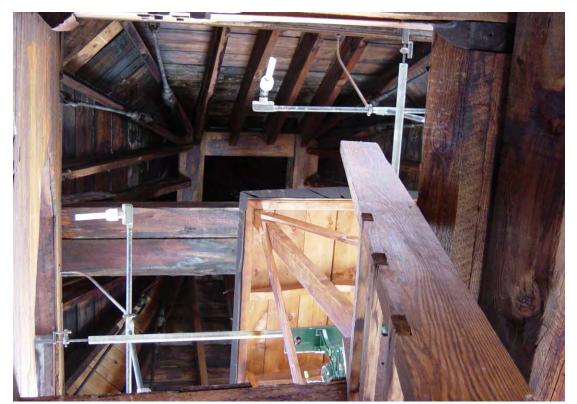
Photo 26 - Timber frame and tension rods appear to be in good condition. Some rot is seen at the roof planks. It is not clear if this is recent, and may be due to condensation rather than leakage. No roof leakage was observed in moderate to heavy rain and winds.

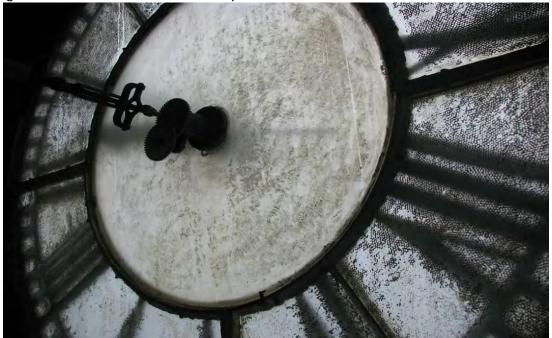
Photo 2 - The clock is not functioning. Deteriorating glazing compound around dial may leak water.
